**Flood Control Project Maintenance
Levee Inspections**
LMA District Cover Sheet
Spring 2019 Levee Inspection Results

Marysville Levee Commission

Spring 2019 Levee Inspection Results

Waterway			Bank	Unit Miles
Unit No. 01 Simmerly Slough			Left	3.23
	Spring (March - May)	Summer (June - August)	(September - November) Fall	Winter (December - February)
Unit Maintenance Rating (Fall Only)				
Date of Inspection	4/17/2019 - 4/17/2019			
DWR Inspector	Sterling York			
Accompanied By	Frank Miller Marysville Levee District

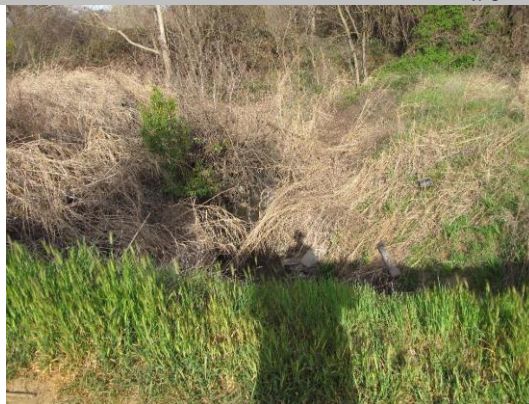
Photo 2 of 3 : UCIP_SP_2019_52792_69743.jpg

View of waterward side from toe road.

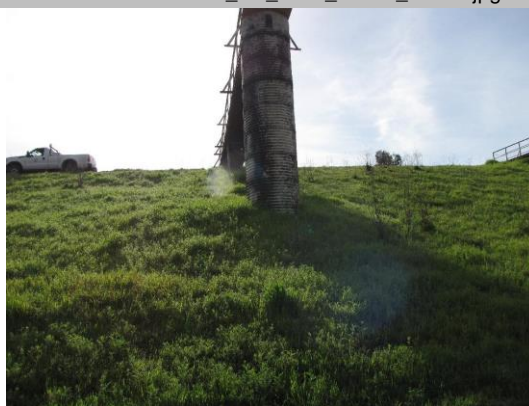
Photo 3 of 3 : UCIP_SP_2019_52792_69742.jpg

Comment Code						
Inspector Comment						
FS_ID:52792						
DS_ID:19090						
EP_NO: N/A						
Repair Type: No Action Needed						
Crossing Status: Found						
UCIP Comments:						
FIELD_STRUCT_DESC: 36-inch corrugated metal drainage pipe through levee, 27 feet below crown. Flap gate and concrete "U" headwall on waterside (WS) end. Slide gate in 48-inch corrugated metal riser on WS slope of pipe. Steel walkway to control gate. Outfall drains from Ellis Lake. Concrete headwall at both toes. Concrete base under riser units. Steel riser unit and slide gate added under Permit No. 4041, 1962-Marysville Levee Commission. [Additional Reference(s): DWR Levee Logs, 1993 and 2005. USACE Sacramento O&M Manual Unit No. 147, August 1955, (Station 8+48)]						
FS Date: 3/14/2013

View of waterward slope.

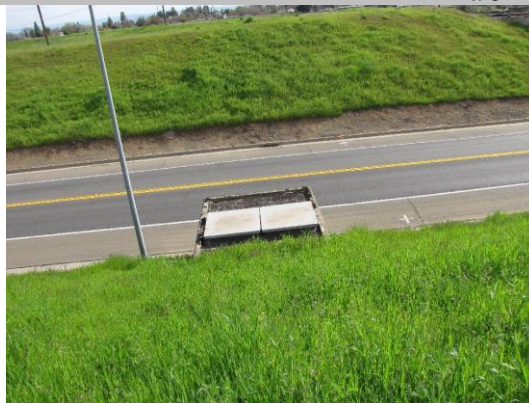
Photo 1 of 3 : UCIP_SP_2019_52796_69758.jpg

Comment Code					
Inspector Comment					
FS_ID:52796 DS_ID:19100 EP_NO: 14518 Repair Type: Non-Urgent Crossing Status: Indicator Found UCIP Comments: 03/14/2013 Recommend having owner removing tall grass along slopes to properly inspect signs of pipe failure. (DWR UCIP - O. Magana) FIELD_STRUCT_DESC: 1 of 2: 10-inch steel drainage pipe through levee, 4 feet below crown. Flap gate on waterside (WS) end. Concrete vault on WS shoulder. Metal meter box on the landside (LS) shoulder. Pump placed on concrete footings at toe of LS slope. Drainage for underpass. Pipes approximately 2.5-feet apart. (10-inch pipe removed and replaced with new 10-inch pipe authorized under Permit No. 14518, 1987-State Department of Transportation). [Additional Reference(s): DWR Levee Logs, 1993 and 2005] FS Date: 3/14/2013

View of landward side.

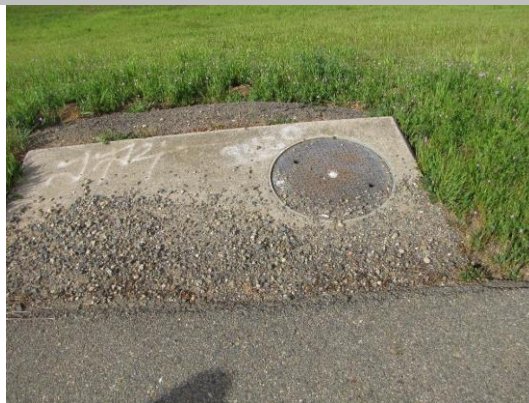
Photo 2 of 3 : UCIP_SP_2019_52796_69757.jpg

Concrete vault on waterward shoulder with manhole.

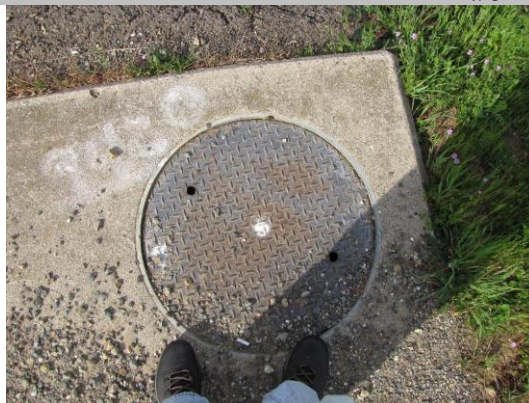
Photo 3 of 3 : UCIP_SP_2019_52796_69756.jpg

Comment Code						
Inspector Comment						
FS_ID:52796 DS_ID:19100 EP_NO: 14518 Repair Type: Non-Urgent Crossing Status: Indicator Found UCIP Comments: 03/14/2013 Recommend having owner removing tall grass along slopes to properly inspect signs of pipe failure. (DWR UCIP - O. Magana) FIELD_STRUCT_DESC: 1 of 2: 10-inch steel drainage pipe through levee, 4 feet below crown. Flap gate on waterside (WS) end. Concrete vault on WS shoulder. Metal meter box on the landside (LS) shoulder. Pump placed on concrete footings at toe of LS slope. Drainage for underpass. Pipes approximately 2.5-feet apart. (10-inch pipe removed and replaced with new 10-inch pipe authorized under Permit No. 14518, 1987-State Department of Transportation). [Additional Reference(s): DWR Levee Logs, 1993 and 2005] FS Date: 3/14/2013

Close up view of manhole.

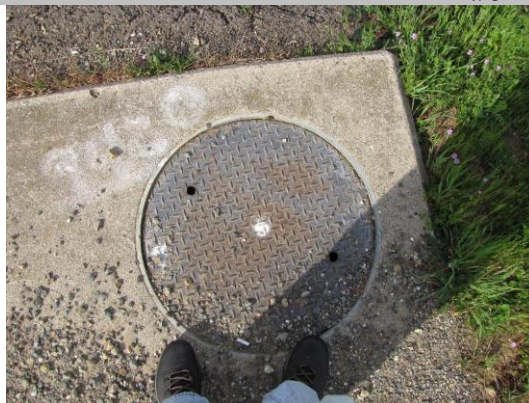
Photo 3 of 3 : UCIP_SP_2019_52797_69760.jpg

Comment Code					
Inspector Comment					
FS_ID:52797 DS_ID:19093 EP_NO: 14518 Repair Type: Non-Urgent Crossing Status: Indicator Found UCIP Comments: 03/14/2013 Recommend having owner removing tall grass along slopes to properly inspect signs of pipe failure. (DWR UCIP - O. Magana) FIELD_STRUCT_DESC: 2 of 2: 10-inch steel drainage pipe through levee, 4 feet below crown. Flap gate on waterside (WS) end. Concrete vault on WS shoulder. Metal meter box on the landside (LS) shoulder. Pump placed on concrete footings at toe of LS slope. Drainage for underpass. Pipes approximately 2.5-feet apart. (10-inch pipe removed and replaced with new 10-inch pipe authorized under Permit No. 14518, 1987-State Department of Transportation). [Additional Reference(s): DWR Levee Logs, 1993 and 2005] FS Date: 3/14/2013

Close up of manhole.

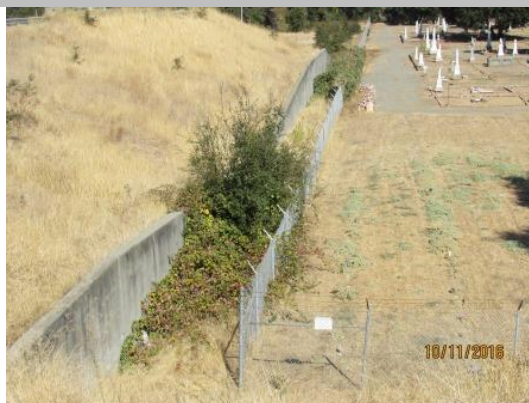
Photo 1 of 1 : SP_2019_NA0004_104_36_20190305_00001.jpg

LM Start	0.97	Rating **	M	Issue No.	36
LM End	1.19	Issue Type +	En	Location *	WS
Category	Earthen Levee			GPS Latitude/Longitude	
				Start	End
Item	Encroachments			39.159210 °	39.161576 °
				-121.590033 °	-121.590721 °
DWR ID	DWR_NA0004_01_f_2013_36				
Comment Code					
RW : Retaining Wall					
Inspector Comment					
A concrete retaining wall was cut into levee toe, no permit found.

View of the concrete retaining wall at the toe of the levee on the waterward side looking downstream.

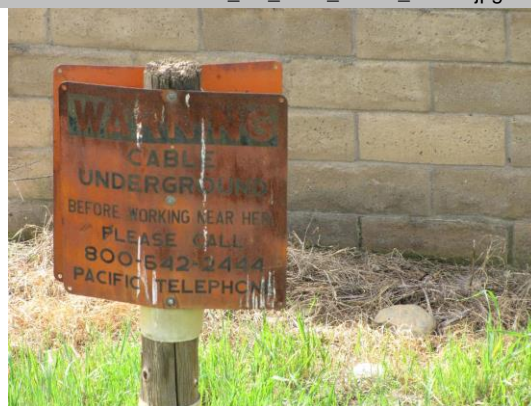
Photo 1 of 3 : UCIP_SP_2019_52799_69766.jpg

Comment Code					
Inspector Comment					
FS_ID:52799 DS_ID:19115 EP_NO: 12878 Repair Type: Non-Urgent Crossing Status: Indicator Found UCIP Comments: 03/14/2013 Need to contact owner to determine additional information about crossing and alignment. (DWR UCIP - O. Magana) FIELD_STRUCT_DESC: 24-inch steel pipe encasing 4-inch polyvinyl chloride (PVC) communications extension through the levee, annular gap grouted, 8 feet below levee crown. Cutoff wall (12x12x20-inch) around extension from levee slopes. (underground communication extension authorized under Permit No. 12878, 1980-Pacific Telephone and Telegraph Company). [Additional Reference(s): DWR Levee Logs, 1993 and 2005] FS Date: 3/14/2013

Marker on landward side.

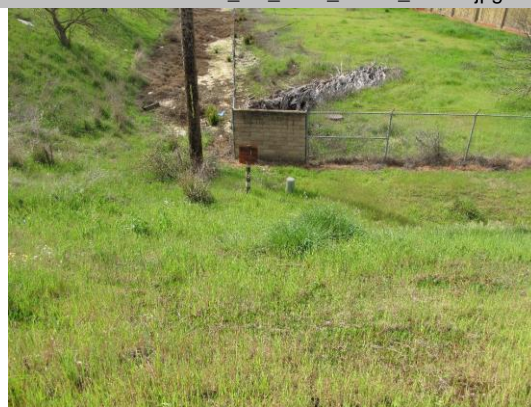
Photo 2 of 3 : UCIP_SP_2019_52799_69765.jpg

View of landward side.

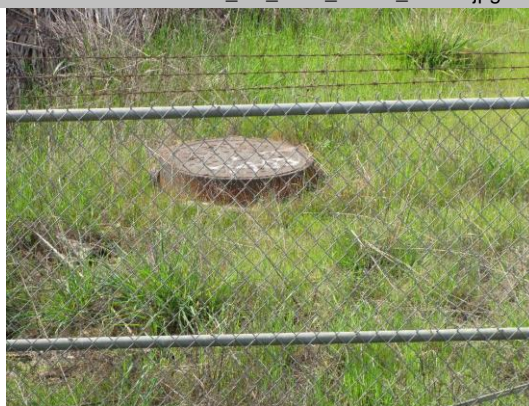
Photo 3 of 3 : UCIP_SP_2019_52799_69764.jpg

Comment Code						
Inspector Comment						
FS_ID:52799						
DS_ID:19115						
EP_NO: 12878						
Repair Type: Non-Urgent						
Crossing Status: Indicator Found						
UCIP Comments: 03/14/2013 Need to contact owner to determine additional information about crossing and alignment. (DWR UCIP - O. Magana)						
FIELD_STRUCT_DESC: 24-inch steel pipe encasing 4-inch polyvinyl chloride (PVC) communications extension through the levee, annular gap grouted, 8 feet below levee crown. Cutoff wall (12x12x20-inch) around extension from levee slopes. (underground communication extension authorized under Permit No. 12878, 1980-Pacific Telephone and Telegraph Company). [Additional Reference(s): DWR Levee Logs, 1993 and 2005]						
FS Date: 3/14/2013

Manhole located behind fenced area on landward side.

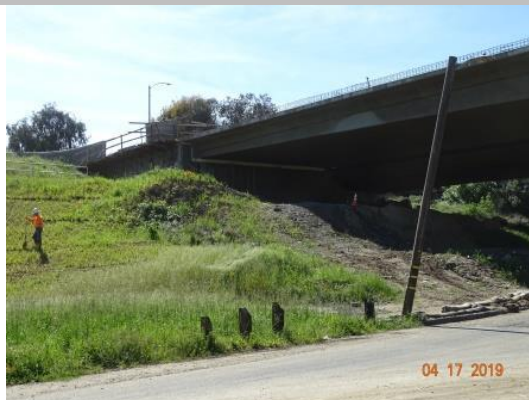
Photo 1 of 1 : SP_2019_NA0004_105_5_20190418_00010.jpg

View looking at the Fifth Street Bridge abutment waterside on the left bank of the Feather River, completion is estimated for the end of 2019.

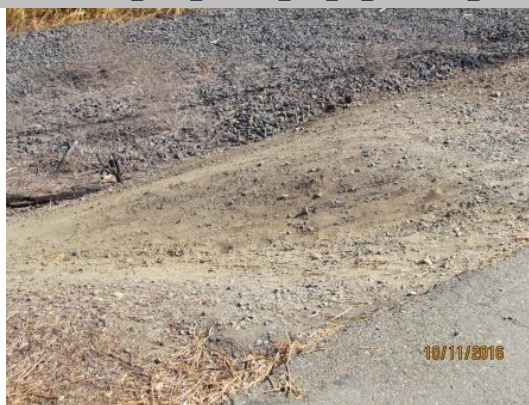
Photo 1 of 1 : SP_2019_NA0004_105_13_20190305_00002.jpg

LM Start	0.82	Rating **	M	Issue No.	13
LM End	0.82	Issue Type +	Ma	Location *	LS
Category	Earthen Levee			GPS Latitude/Longitude	
				Start	End
Item	Slope Stability			39.138827 °	39.138827 °
				-121.599530 °	-121.599530 °
DWR ID	DWR_NA0004_02_f_2016_13				
Comment Code					
S2 : Repair the levee slope damaged by foot traffic and prevent access where possible.					
Inspector Comment					
Foot path depression in the landside levee slope needs to be repaired.

View of foot path depression in the landside levee slope.

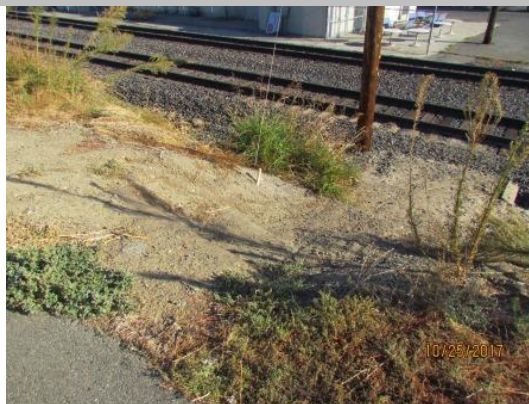
Photo 1 of 1 : SP_2019_NA0004_105_14_20190305_00003.jpg

LM Start	0.85	Rating **	M	Issue No.	14
LM End	0.85	Issue Type +	Ma	Location *	LS
Category	Earthen Levee			GPS Latitude/Longitude	
				Start	End
Item	Slope Stability			39.138463 °	39.138463 °
				-121.599168 °	-121.599168 °
DWR ID	DWR_NA0004_02_f_2016_14				
Comment Code					
S2 : Repair the levee slope damaged by foot traffic and prevent access where possible.					
Inspector Comment					
Remove steps that are cut into levee slope.

View of steps for foot path in the landside levee slope.

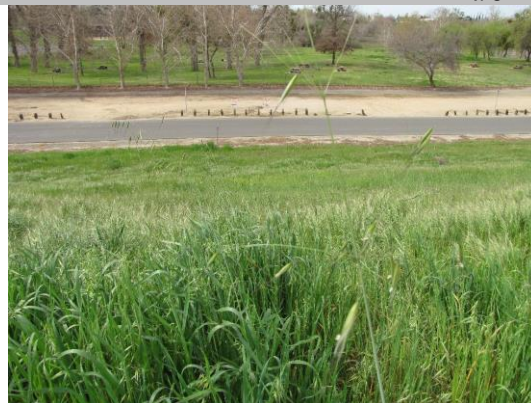
Photo 1 of 3 : UCIP_SP_2019_52808_69802.jpg

LM Start	0.87	Rating **	M	Issue No.	15
LM End	0.87	Issue Type +	En	Location *	
Category	Supplemental			GPS Latitude/Longitude	
				Start	End
Item	DWR UCIP Field Study			39.138269 °	39.138269 °
				-121.599004 °	-121.599004 °
DWR ID	19123				
Comment Code					
Inspector Comment					
FS_ID:52808 DS_ID:19123 EP_NO: N/A Repair Type: Non-Urgent Crossing Status: Indicator Found UCIP Comments: 03/15/2013 Unable to tell if crossing goes through levee; according to Frank Miller crossing does not cross levee. Need to contact owner to confirm alignment. (DWR UCIP - O. Magana) FIELD_STRUCT_DESC: Fiber optics communication line of unknown material through levee at an unknown depth below the crown. Marker on waterside (WS) shoulder. [Additional Reference(s): DWR Levee Logs, 1993 and 2005] FS Date: 3/15/2013

View of waterward slope.

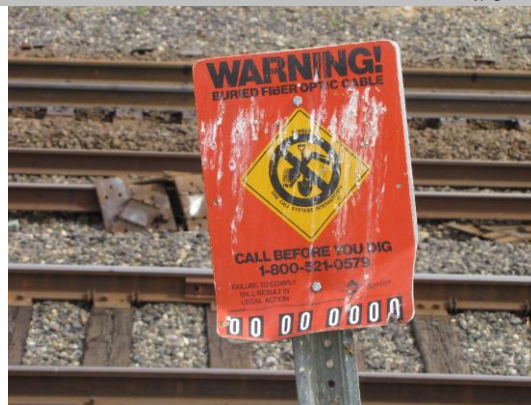
Photo 2 of 3 : UCIP_SP_2019_52808_69801.jpg

Buried fiber optical cable marker with contact information located on landward shoulder.

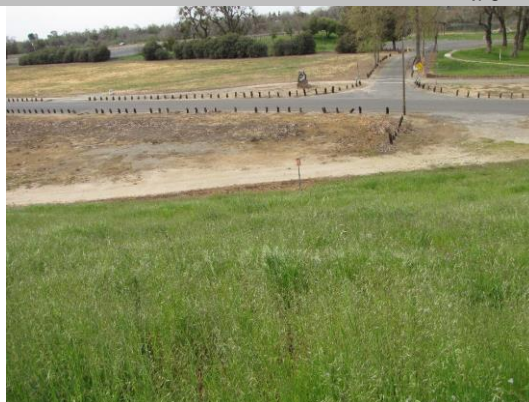
Photo 1 of 3 : UCIP_SP_2019_52809_69804.jpg

LM Start	0.91	Rating **	M	Issue No.	16
LM End	0.91	Issue Type +	En	Location *	
Category	Supplemental			GPS Latitude/Longitude	
				Start	End
Item	DWR UCIP Field Study			39.137749 °	39.137749 °
				-121.598560 °	-121.598560 °
DWR ID	19104				
Comment Code					
Inspector Comment					
FS_ID:52809 DS_ID:19104 EP_NO: N/A Repair Type: Non-Urgent Crossing Status: Indicator Found UCIP Comments: 03/15/2013 Unable to tell if crossing goes through levee. Need to contact owner to confirm alignment. (DWR UCIP - O. Magana) FIELD_STRUCT_DESC: 12-inch high-density polyethylene (HDPE) conduit, with electrical lines, through the levee at an unknown depth through the levee. Extends to controller cabinet within the overflow area. FS Date: 3/15/2013

View of markers located on waterward toe.

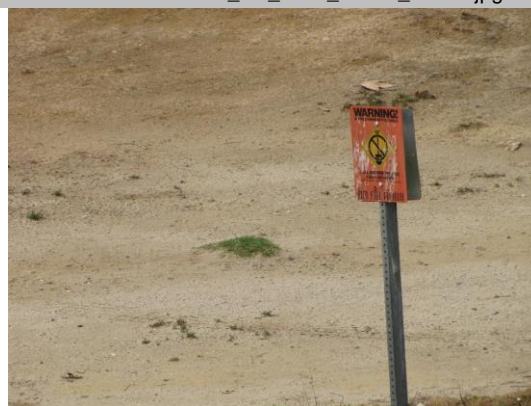
Photo 2 of 3 : UCIP_SP_2019_52809_69805.jpg

LM Start	0.91	Rating **	M	Issue No.	16 (cont)	
LM End	0.91	Issue Type +	En	Location *		
Category	Supplemental			GPS Latitude/Longitude		
				Start	End	
Item	DWR UCIP Field Study			39.137749 °	39.137749 °	
				-121.598560 °	-121.598560 °	
DWR ID	19104					
Comment Code						
Inspector Comment						
FS_ID:52809						
DS_ID:19104						
EP_NO: N/A						
Repair Type: Non-Urgent						
Crossing Status: Indicator Found						
UCIP Comments: 03/15/2013 Unable to tell if crossing goes through levee. Need to contact owner to confirm alignment. (DWR UCIP - O. Magana)						
FIELD_STRUCT_DESC: 12-inch high-density polyethylene (HDPE) conduit, with electrical lines, through the levee at an unknown depth through the levee. Extends to controller cabinet within the overflow area.						
FS Date: 3/15/2013

View of markers located on waterward toe.

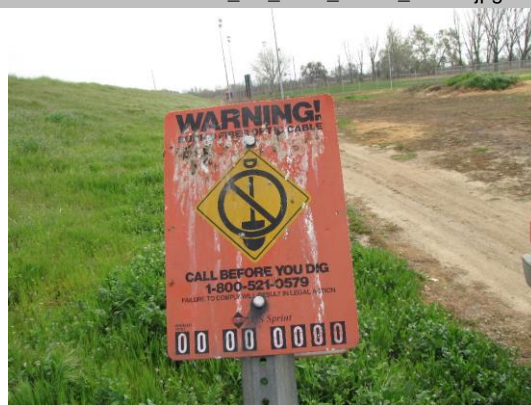
Photo 3 of 3 : UCIP_SP_2019_52809_69806.jpg

Close up of markers located at toe of waterward side.

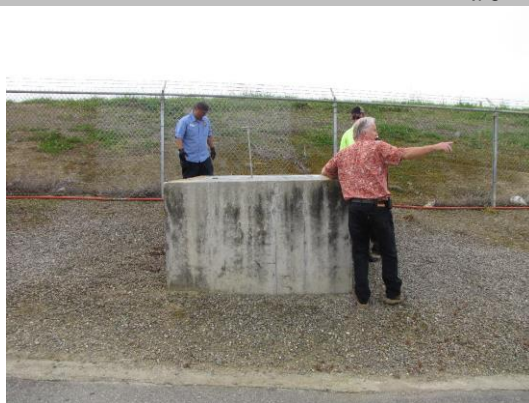
Photo 2 of 3 : UCIP_SP_2019_52811_72680.jpg

View of concrete box located on landward side--crossing not in use according to Marysville Sewage Treatment Plant Manager.

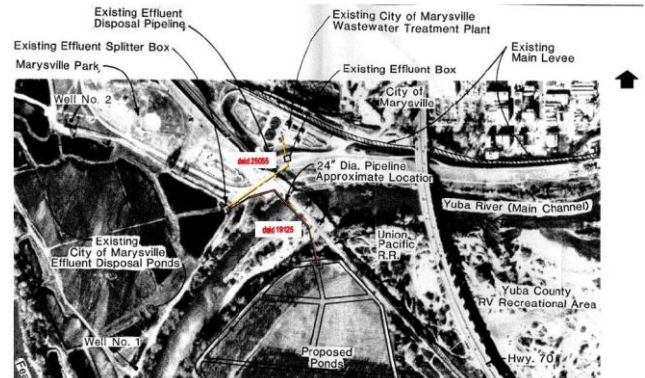
Photo 3 of 3 : UCIP_SP_2019_52811_77949.jpg

FS_ID:52811
DS_ID:25055
EP_NO: N/A
Repair Type: Non-Urgent
Crossing Status: Found
UCIP Comments: 09/14/2018 Pipe size was changed from 10-inch to 12-inch based on drawings made available through Permit 15178 and 15178-1. (DWR UCIP - O. Magana)
03/14/2013 Appears that crossing is currently not in use. If crossing is to be abandoned, owner will need to contact CVFPB to coordinate about proper removal. (DWR UCIP - O. Magana)
FIELD_STRUCT_DESC: 12-inch sewer line visible on landside (LS). According to Marysville Treatment Plant Manager this crossing was installed in 1995-1996. Coordinates for box located on LS: 39.135185, -121.593254. Note coordinates used for levee crossing are projected coordinates. 12-inch gravity flow pipelines goes through levee and the 36-inch pipeline parallels with the waterside toe of the right bank levee of the Yuba River. (12-inch extending-to-36-inch-diameter chlorine contact pipe line authorized under Permit 16055, 1993-City of Marysville; related permit - existing 12-inch line connects to effluent splitter box located southwest at the City of Marysville Effluent Disposal Ponds along the right bank of the Yuba River and new 24-inch installed at existing effluent splitter box and connects to the Proposed ponds along the left bank of the Yuba River work authorized under Permit 15178, 1989 - City of Marysville Department of Public Works)

Alignment of crossing through levee per dwgs under Permit 15178 and 15178-1.

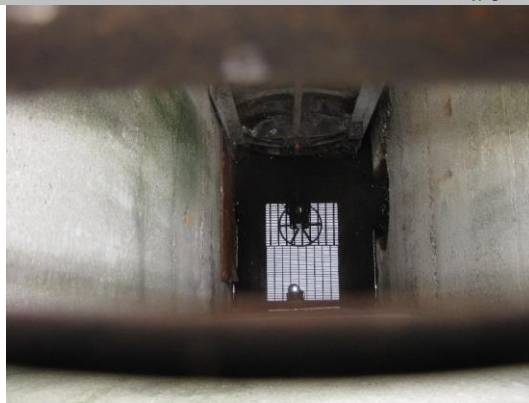
Photo 1 of 3 : UCIP_SP_2019_52812_69812.jpg

Comment Code					
Inspector Comment					
FS_ID:52812					
DS_ID:19126					
EP_NO: N/A					
Repair Type: Non-Urgent					
Crossing Status: Found					
UCIP Comments: 03/15/2013 Owner will need to coordinate with DWR-Inspector and CVFPB to determine if crossing meets Title 23 requirements for proper abandonment. (DWR UCIP - O. Magana)					
FIELD_STRUCT_DESC: *ABANDONED* 24-inch drainage pipe of unknown material through levee at an unknown depth. Pipe completely grouted in levee section, cut at slopes. Coordinates for box located on landward side: 39.135259, -121.592593. Note coordinates used for levee crossing are projected coordinates. (24-inch pipe grouted within the levee section authorized under Permit No. 4174, 1963-City of Marysville)					
FS Date: 3/15/2013

Abandoned line sealed with metal plate.

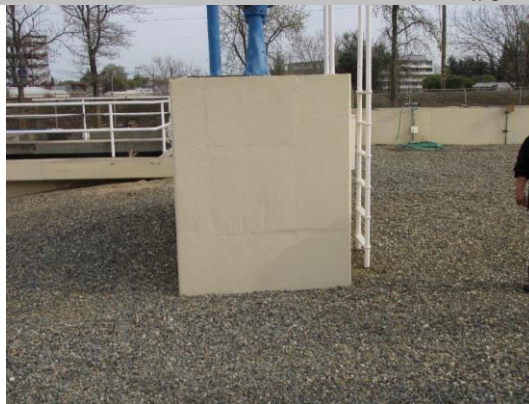
Photo 2 of 3 : UCIP_SP_2019_52812_69811.jpg

Standpipe where old line is still located.

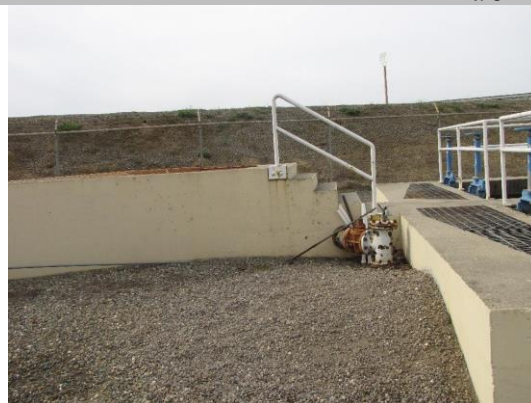
Photo 3 of 3 : UCIP_SP_2019_52812_69810.jpg

Comment Code					
Inspector Comment					
FS_ID:52812 DS_ID:19126 EP_NO: N/A Repair Type: Non-Urgent Crossing Status: Found UCIP Comments: 03/15/2013 Owner will need to coordinate with DWR-Inspector and CVFPB to determine if crossing meets Title 23 requirements for proper abandonment. (DWR UCIP - O. Magana) FIELD_STRUCT_DESC: *ABANDONED* 24-inch drainage pipe of unknown material through levee at an unknown depth. Pipe completely grouted in levee section, cut at slopes. Coordinates for box located on landward side: 39.135259, -121.592593. Note coordinates used for levee crossing are projected coordinates. (24-inch pipe grouted within the levee section authorized under Permit No. 4174, 1963-City of Marysville) FS Date: 3/15/2013

View of levee slope on waterward.

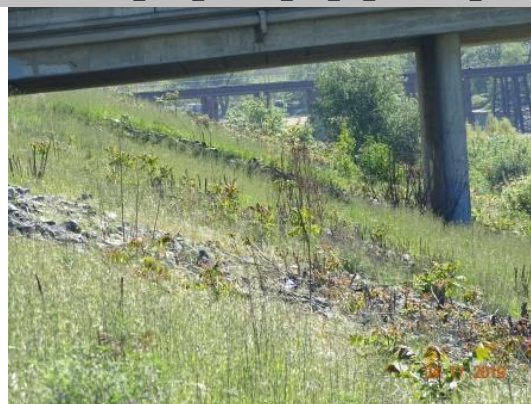
Photo 1 of 1 : SP_2019_NA0004_106_16_20190418_00046.jpg

View looking upstream waterside where intrusive starter trees have been trimmed and sprayed, Spring 2019.

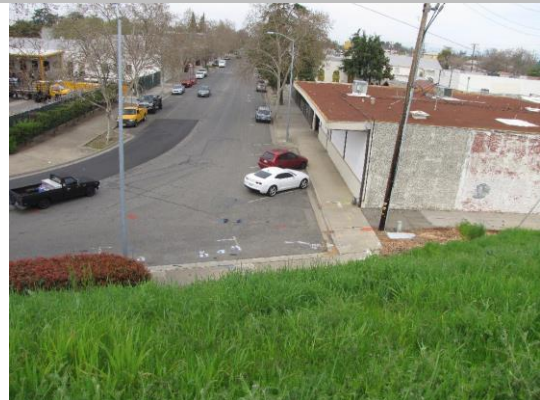
Photo 1 of 2 : UCIP_SP_2019_52815_72683.jpg

Underground service alert (USA) blue paint indicators of water line present on landward side.

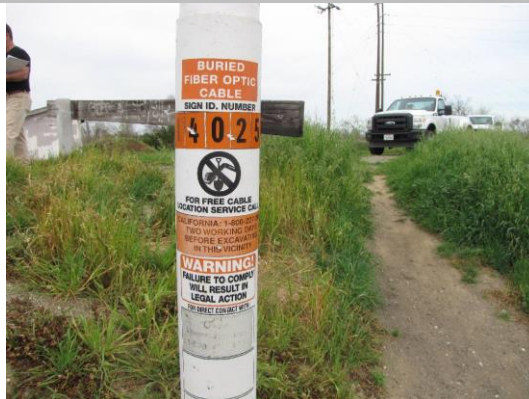
Photo 3 of 3 : UCIP_SP_2019_52819_72694.jpg

Fiber Optic Cable marker visible on landward side.

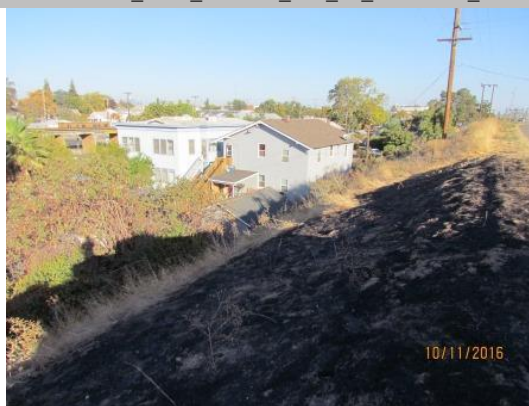
Photo 1 of 1 : SP_2019_NA0004_106_25_20190305_00004.jpg

View of house and shed at the landside levee toe looking upstream.

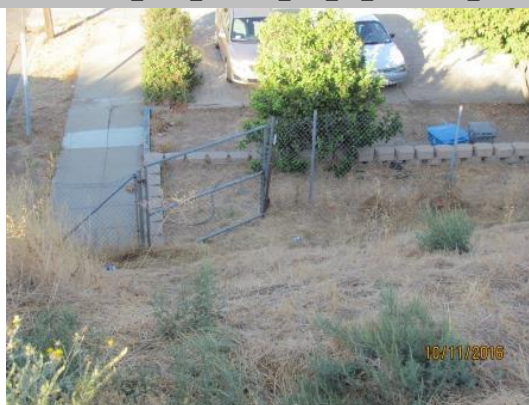
Photo 1 of 1 : SP_2019_NA0004_106_26_20190305_00005.jpg

View of fence that runs along landside levee toe.

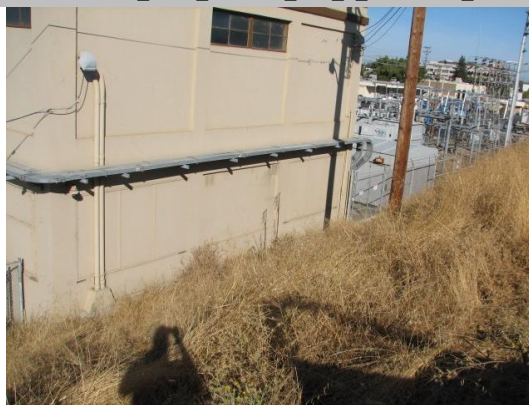
Photo 1 of 1 : SP_2019_NA0004_106_4_20190305_00001.jpg

Building encroaching at landside levee toe.

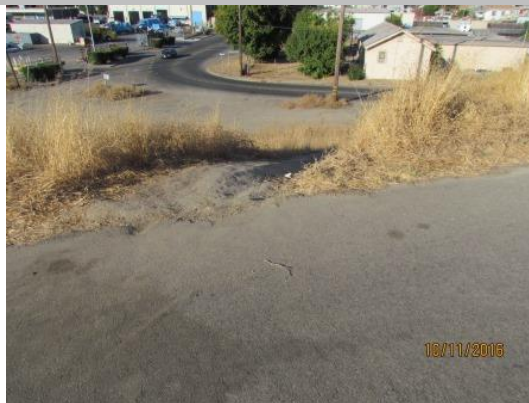
Photo 1 of 1 : SP_2019_NA0004_106_30_20190305_00006.jpg

View of path cut in by foot traffic on the landside slope.

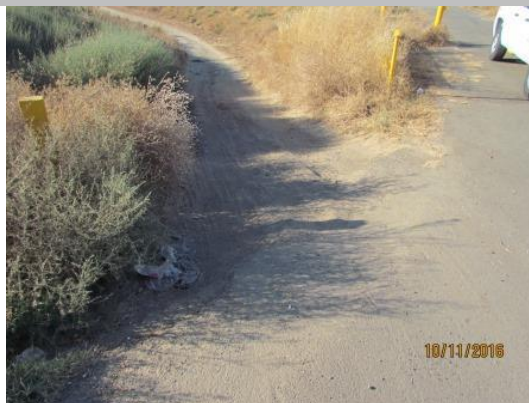
Photo 1 of 1 : SP_2019_NA0004_106_32_20190305_00007.jpg

View of ruts cut in by vehicle traffic on the waterside slope.

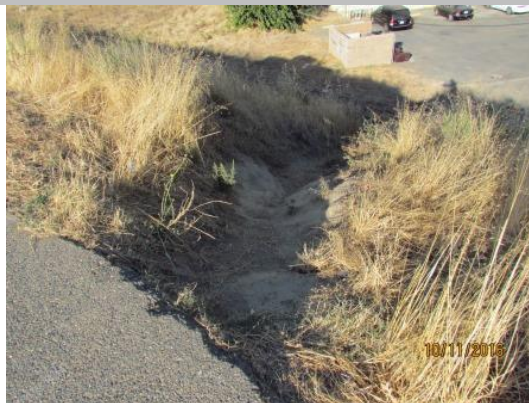
Photo 1 of 1 : SP_2019_NA0004_106_33_20190305_00008.jpg

View of path cut in by foot traffic on the landside slope that needs repaired.

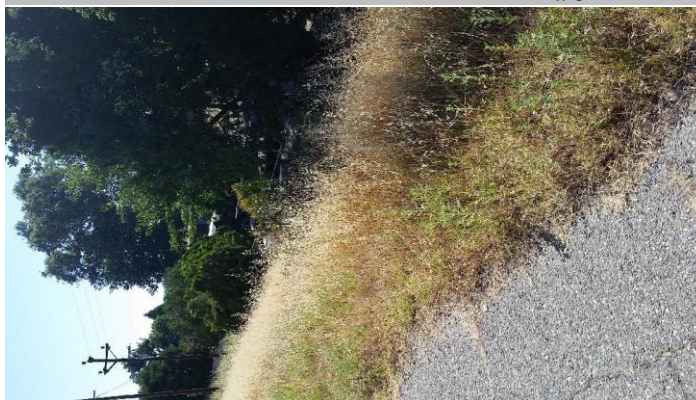
Photo 2 of 3 : UCIP_SP_2019_52821_75778.jpg

View of WS--dense vegetation on slope.

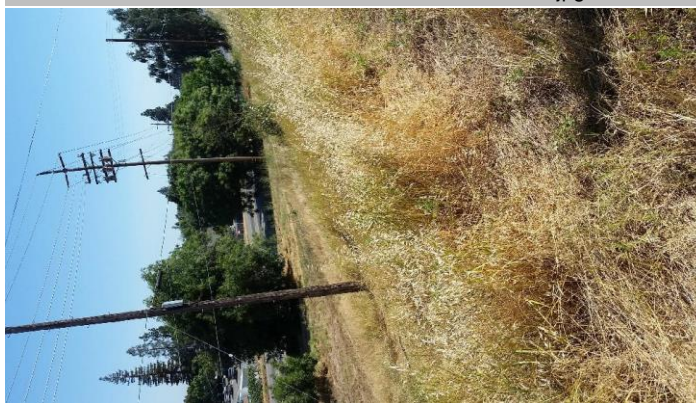
Photo 3 of 3 : UCIP_SP_2019_52821_75779.jpg

View of LS--dense vegetation on slope.

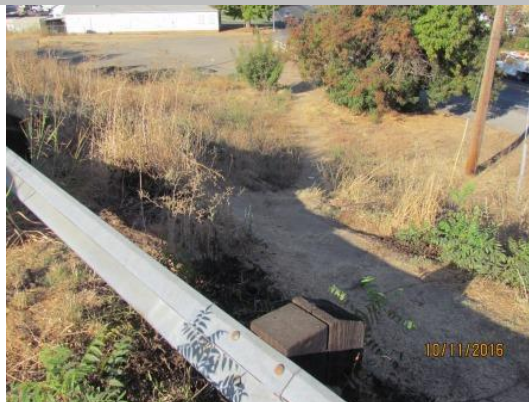
Photo 1 of 1 : SP_2019_NA0004_106_18_20190305_00003.jpg

View of foot path that has cut into landside levee slope.

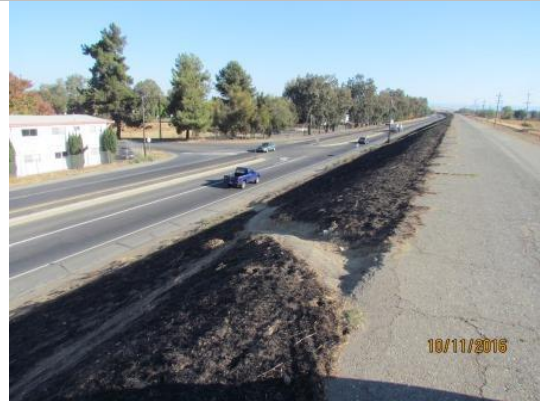
Photo 1 of 1 : SP_2019_NA0004_106_39_20190305_00011.jpg

View looking upstream of foot path that has cut into the landside levee slope.

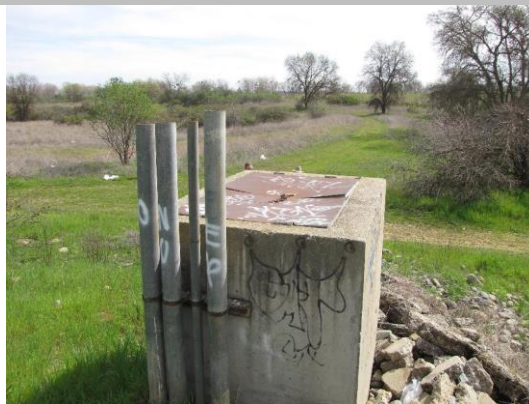
Photo 3 of 3 : UCIP_SP_2019_52824_69828.jpg

Concrete box and vent pipes located on waterward side.

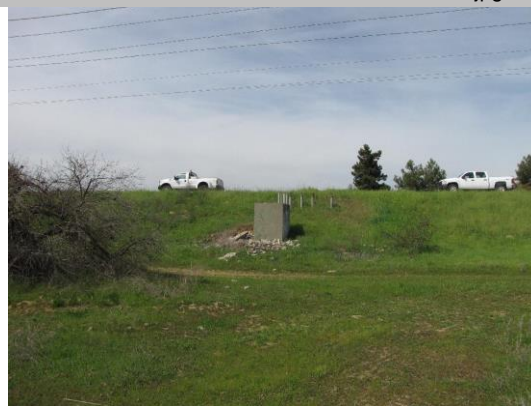
Photo 2 of 3 : UCIP_SP_2019_52825_69834.jpg

Concrete box and vent pipes located on waterward slope.

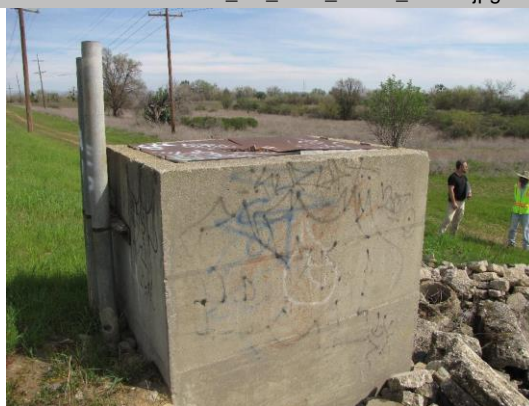
Photo 3 of 3 : UCIP_SP_2019_52825_69833.jpg

Concrete box located on waterward slope.

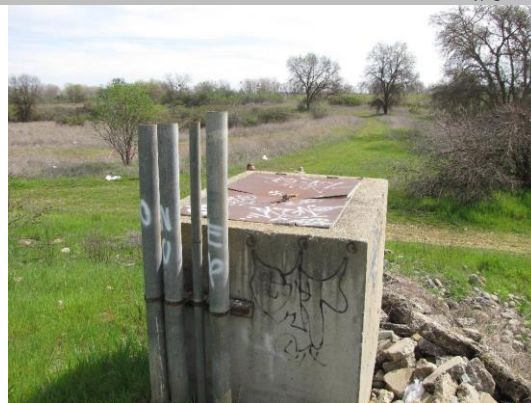
Photo 3 of 3 : UCIP_SP_2019_52826_69838.jpg

Concrete stand pipe located on waterward shoulder.

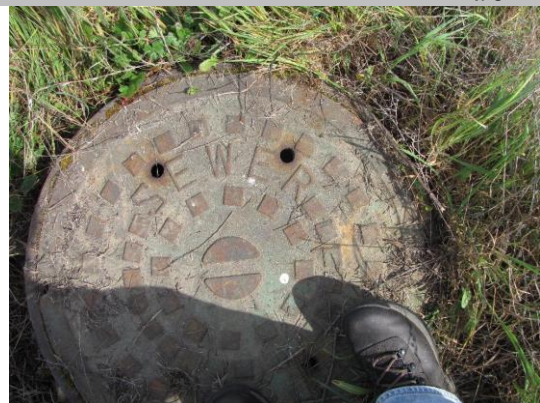
Photo 1 of 2 : UCIP_SP_2019_52828_25149.jpg

Manhole located on landward toe.

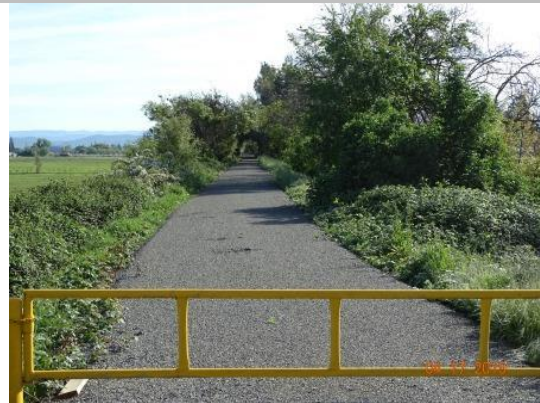
Photo 1 of 1 : SP_2019_NA0004_106_17_20190418_00043.jpg

View looking upstream crown of the section of levee that is only a patrol road and used in the case of emergency for evacuation access.

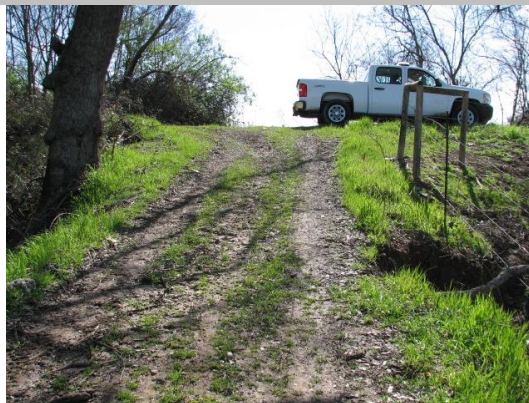
Photo 1 of 1 : SP_2019_NA0004_106_10_20190305_00002.jpg

This ramp is on the patrol road, no known permit.
